Field-level Assessment of Mg-rich Primer

John Stropki (Battelle) Jim Tankersley (Battelle)

Environment, Energy & Sustainability Symposium Denver, CO May 7, 2009

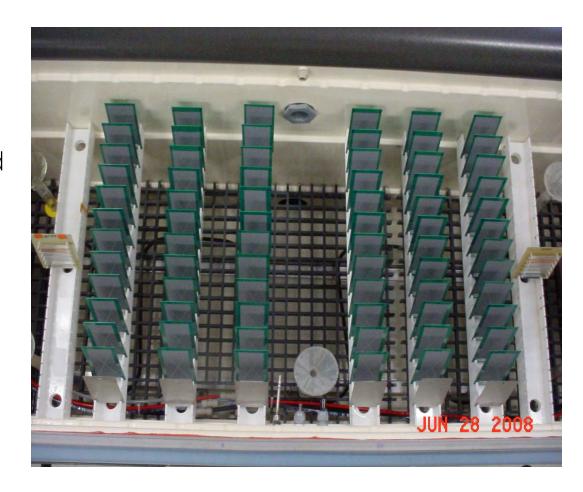
- ASTM B-117 Exposure Testing of Coated Test Panels
 - Required 3,000 hour or 125 day exposure period with visual assessments every 504 hours
 - ANAC and AFRL coated panels (Aerodur 2100)
 - First exposure test terminated after ~650 hours by AFRL/CTIO because of test protocol issues (i.e., X-scribe morphology and test environment)

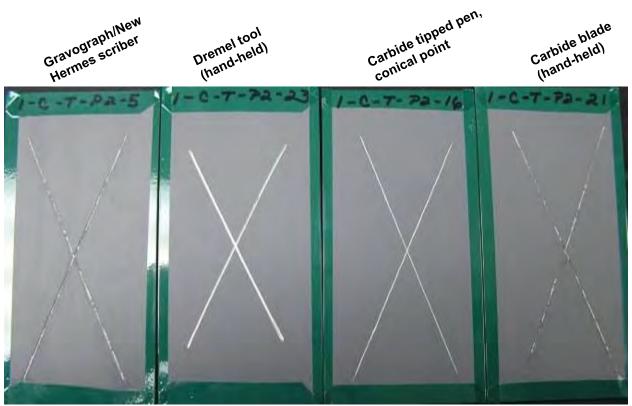
- Must seriously address the issue of scribe morphology on potential performance in B-117 test environment
 - Growing body of evidence showing that "rough" scribes can have a serious impact on performance, even for Cr controls

ANAC generated scribe variability on Cr controls; same topcoated, Cr-primer system, four different scribe methods after 650 hours of B-117

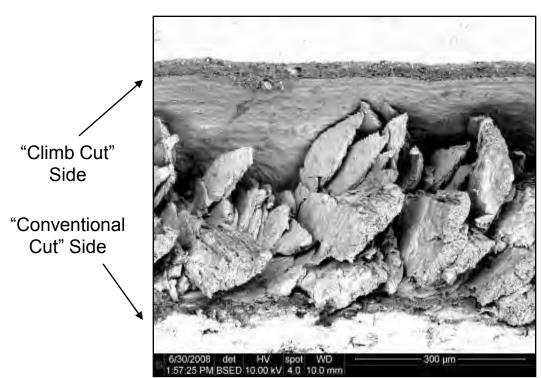
Sample 799-A1D-016 2024-T3 Bare

- In nearly all cases, significant amounts of corrosion product is seen on the rough "conventional cut" side of the scribe and very little on the smooth "climb cut" side
- Reduced Chromate Control
 - PreKote / Deft 02-Y-40 / Deft 99-GY-001 (color 36173)

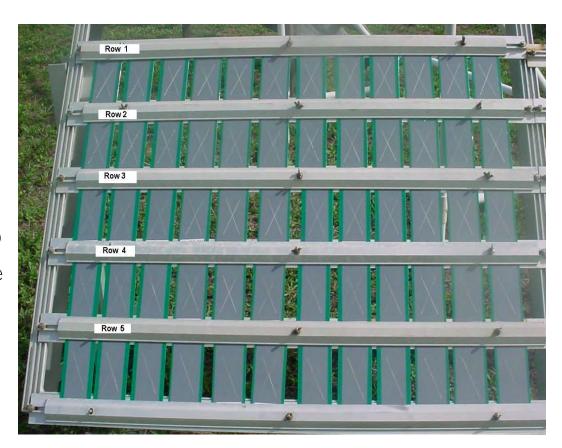
- Exposure Testing of Coated Test Panels
 - 12-month Exposure Tests
 - Commenced June 25, 2008 at FMRF
 - Commenced October 9, 2008 at FANG
 - Nine month FMRF exposure conducted on March 18, 2009
 - No significant change in scribe rating
 - Undercutting detected on select panel sets
 - Blistering on "blank" test panels (no primer)
 - No major chalking, gloss or color changes (ΔE<1)

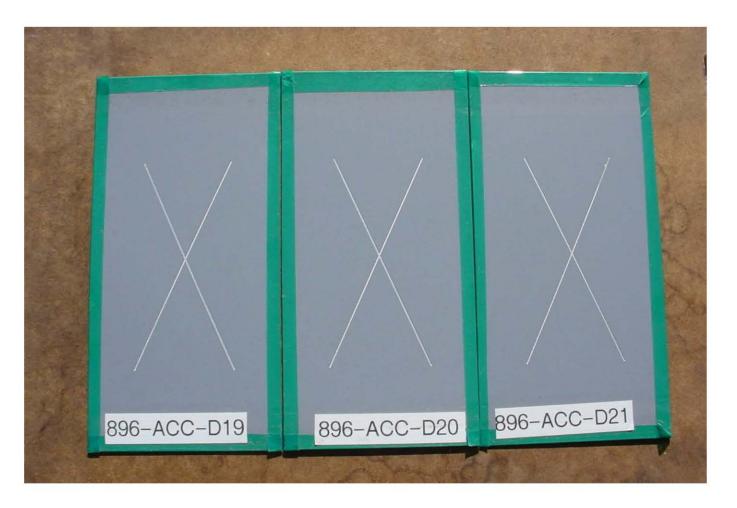
9-month Exposure Results
- no visual changes noted
(typical)
